HIGHLAND LAKE NORTH OUTLET

NH 00238

PHASE I INSPECTION REPORT
NATIONAL DAM INSPECTION PROGRAM

AUGUST 1978

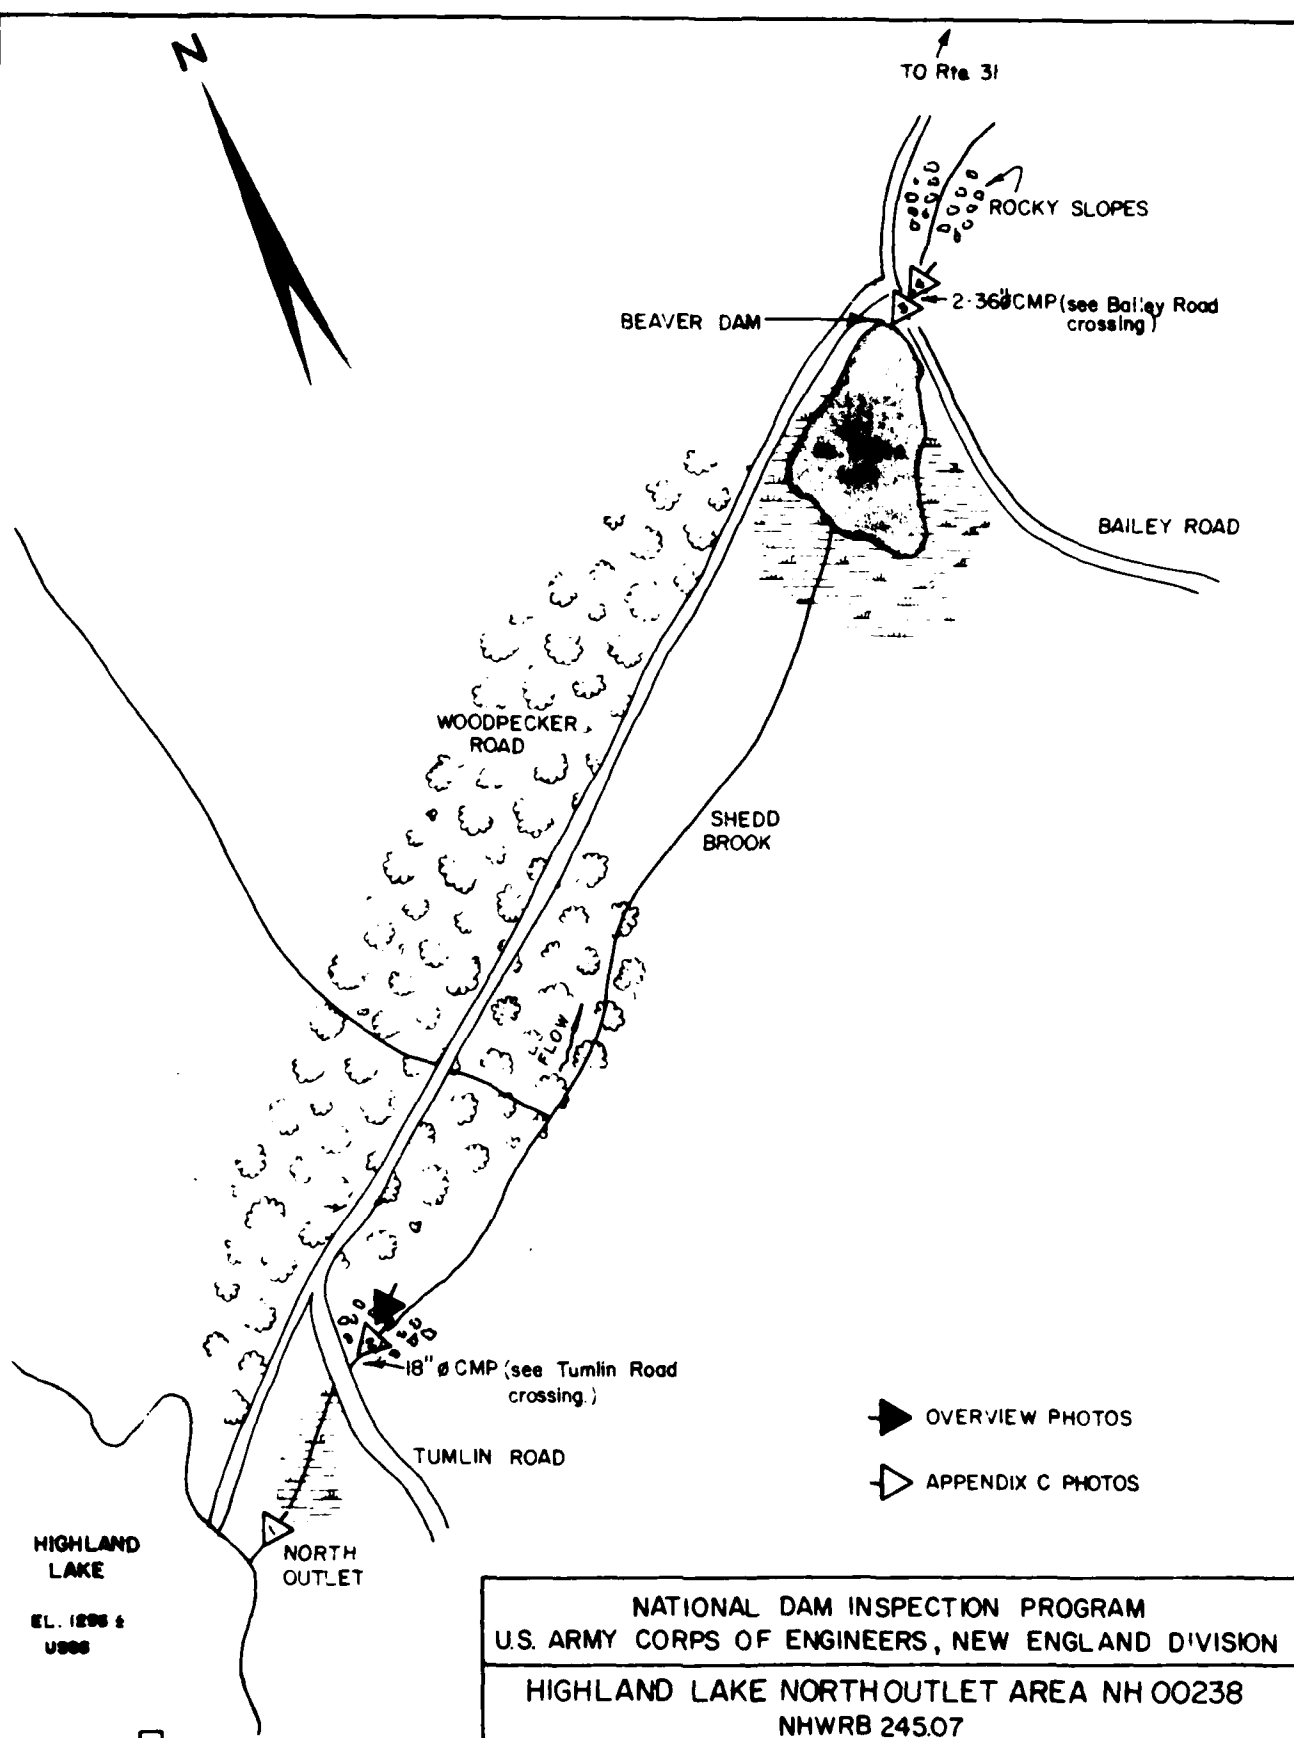
NATIONAL DAM INSPECTION PROGRAM
U.S. ARMY CORPS OF ENGINEERS, NEW ENGLAND DIVISION
HIGHLAND LAKE NORTHOUTLET AREA NH 00238
NHWRB 245.07
SITE PLAN
JULY 1978
SCALE: 1" = 0.1 mi
FIG. 1

As mentioned above the North Outlet is not a formal structure, being merely an overflow from the lake to Shedd Brook (Fig. 1). Prior to the construction of what is now called the South Outlet, Highland Lake was actually three separate, smaller bodies of water. Placement of the dam at the south end resulted in the three smaller ponds consolidating into what is now the larger Highland Lake. At that time, the dam builder, a predecessor company of the Public Service Company of New Hampshire, designated Shedd Brook, which formerly served as the outflow for the original northermost pond, as the emergency spillway for the new dam. While a 1932 New Hampshire Water Resources Board (NHWRB) report indicates that a rock-filled, timber crib dam built to provide a spillway did exist in this area, there is currently no visible control structure of any type at the outlet itself. The outlet is approximately 2.5 feet wide and 1.5 feet deep and its invert is essentially at USGS E1.1295+, or only slightly below the lake's normal level. A beaver dam at the lake's shore completely blocks any flow that might occur under normal lake elevation (Figure 1).

Approximately 500 feet downstream of the outlet, Tumlin Road crosses Shedd Brook (Figure 1). The road at this point is basically an earth embankment, 30 feet wide at its base and with a 16 foot wide travelled
